ASBESTOS AND LEAD BASED PAINT SURVEY REPORT
SOLANO COMMUNITY COLLEGE
4000 SUISUN VALLEY ROAD
FAIRFIELD, CALIFORNIA

July 20, 2004

Kleinfelder Job No. 44156
July 20, 2004

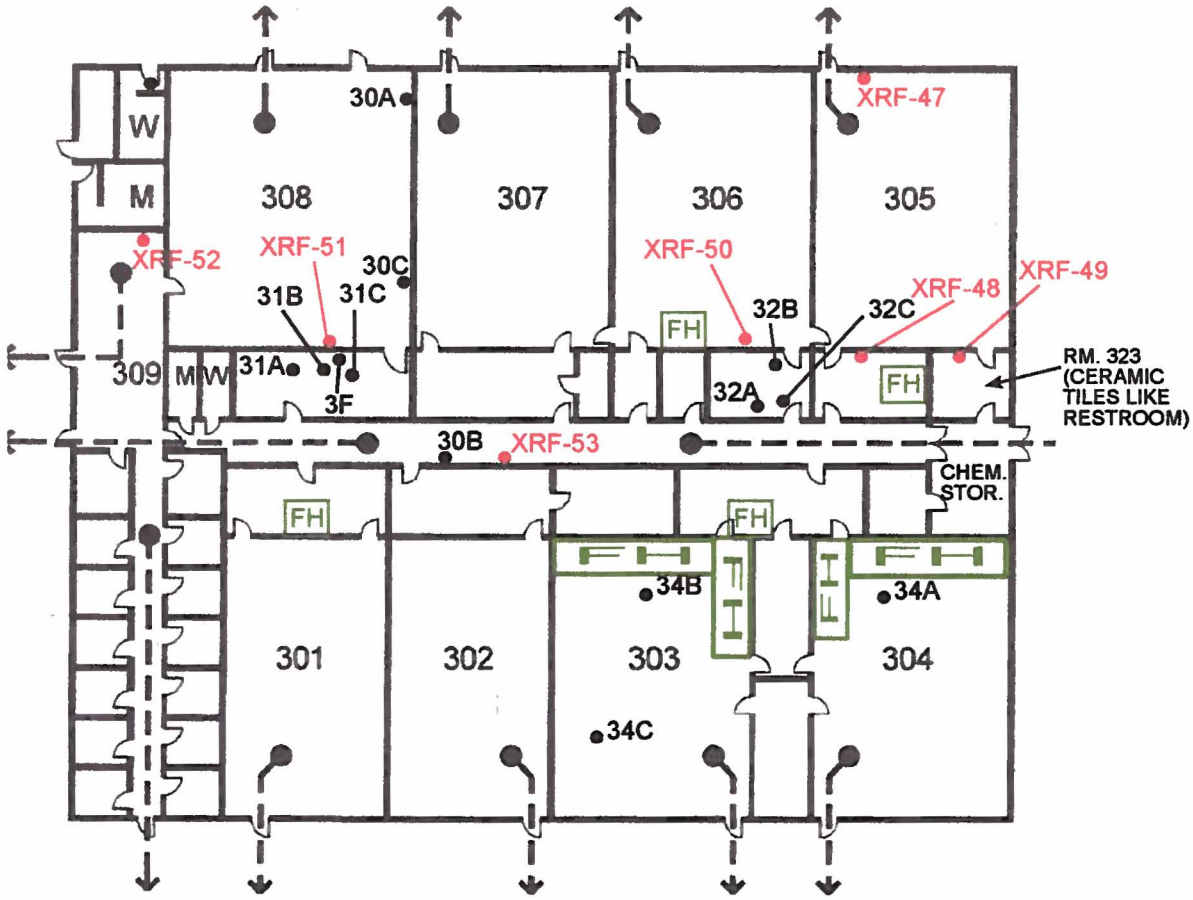
NOTES: BUILDING MATERIALS WHICH CONTAIN ASBESTOS INCLUDE THE FOLLOWING: GRAY PUTTY ASSOCIATED WITH THE BLACK LAB SINKS, TRANSITE PANELS WITHIN THE SPECIFIED FUME HOODS, BEIGE HVAC TAPING LOCTED IN THE PLENUM AREA, AND ALL 9"x9" / 12"x12" VFT AND MASTIC.

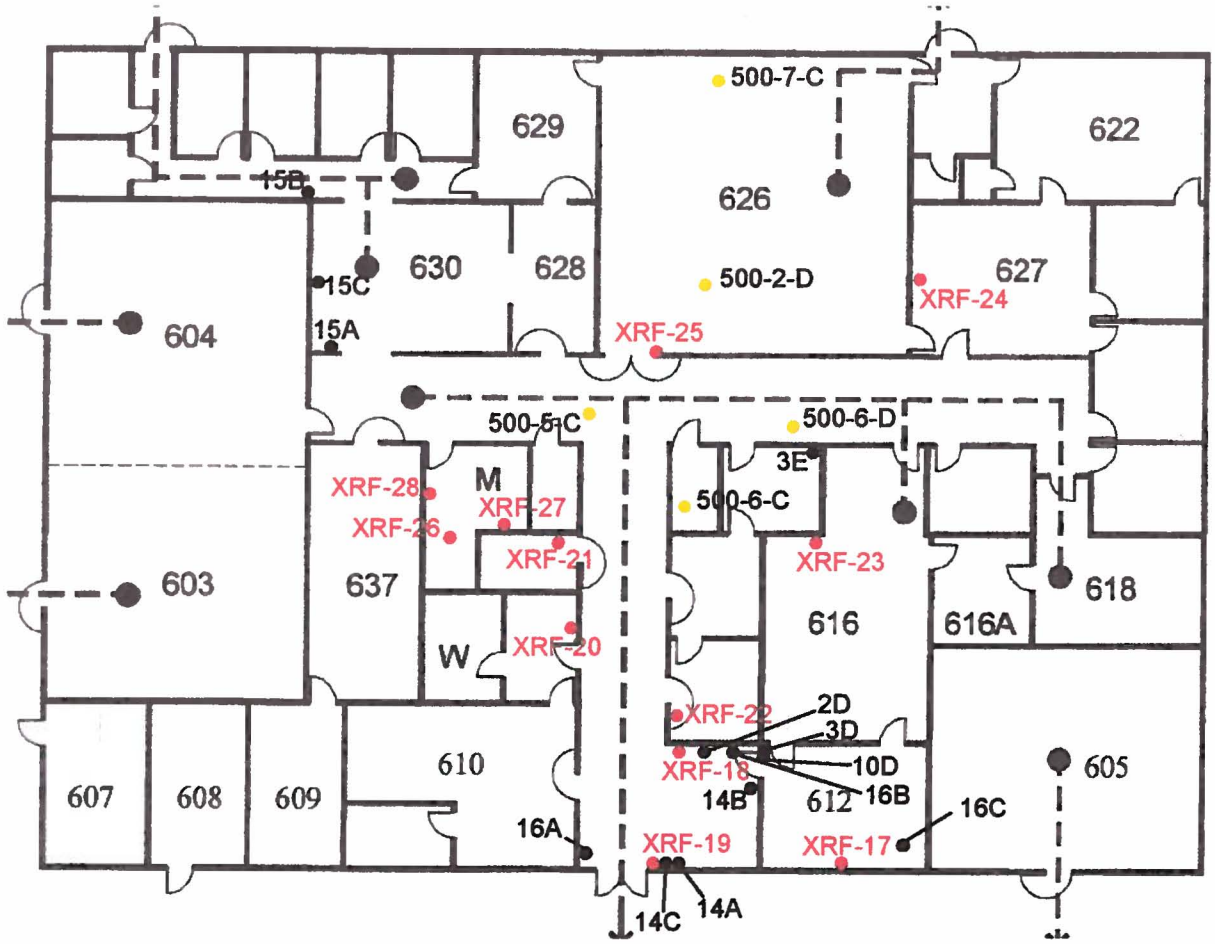
DUE TO FIELD CONDITIONS THE FOLLOWING MATERIALS WERE NOT SAMPLED AND ARE ASSUMED TO CONTAIN ASBESTOS: WOOD WALL SIDING LOCATED IN ROOM 616 AND 626.

IN ADDITION, THE WALKWAY OVERHANG BETWEEN BUILDING 500 AND 600 WAS BUILT IN 1988, THEREFORE, SAMPLES WERE NOT COLLECTED.

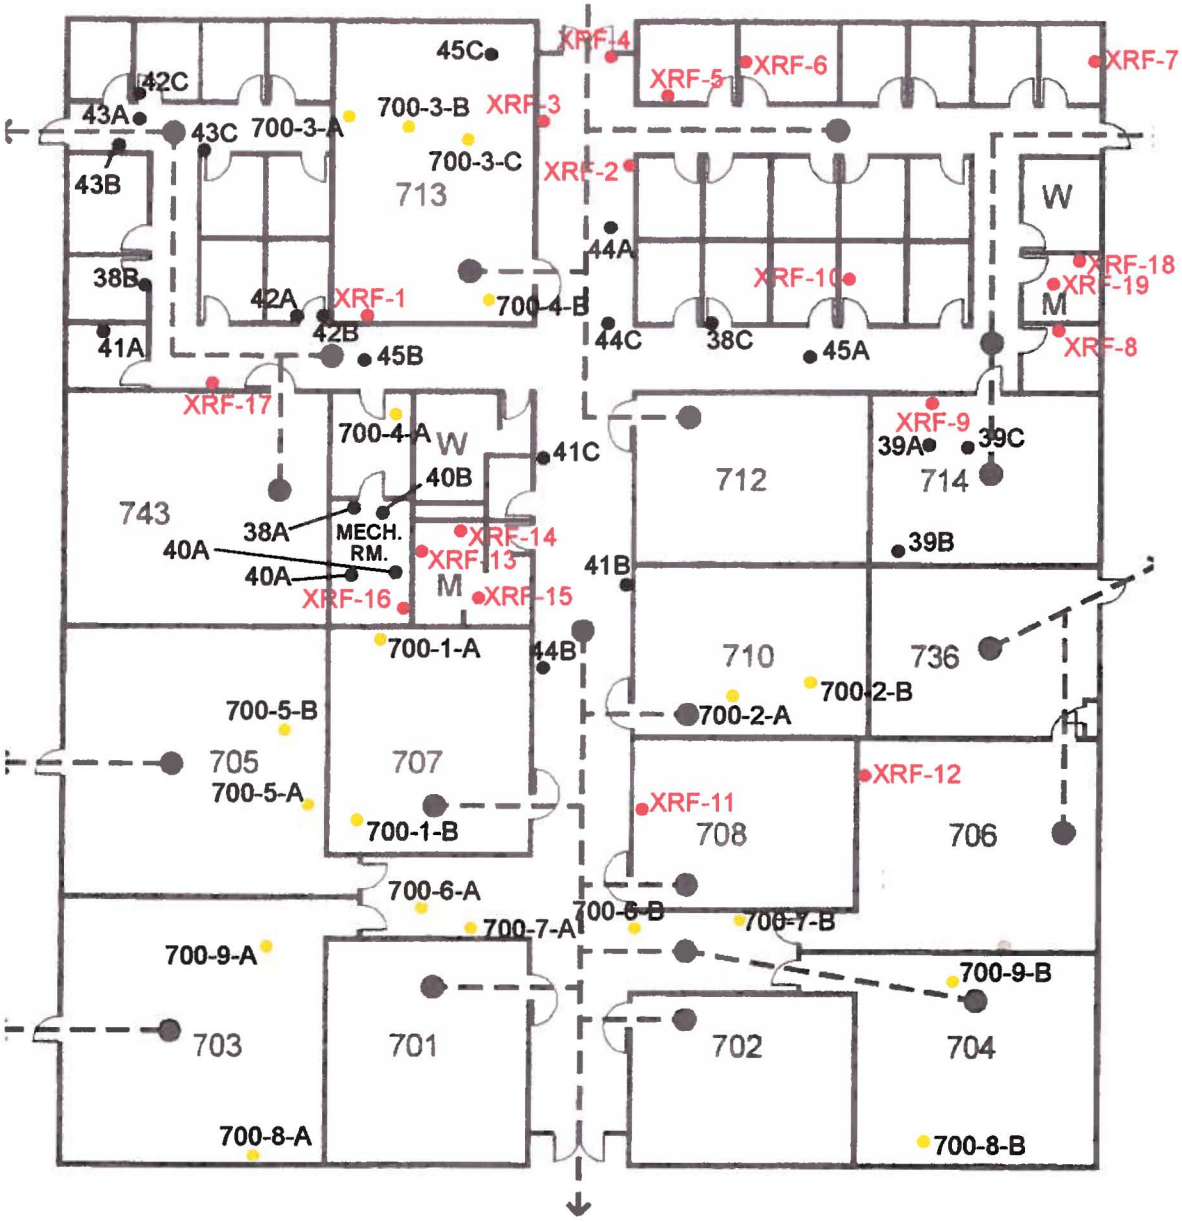
NOTES: BUILDING MATERIALS WHICH CONTAIN ASBESTOS INCLUDE THE FOLLOWING: ALL 9"x9"/12"x12" VFT/MASTIC AND SHEETROCK WALL SYSTEMS. ASBESTOS CONTAINING MATERIALS ON THE ROOF CONSIST OF THE BLACK ROLLED ROOFING MATERIAL LOCATED IN THE PARAPIT, GRAY PVC PUTTY LOCATED IN THE PARAPIT, BLACK ASPHALT ROLLED ROOFING MATERIAL AND BLACK PUTTY LOCATED ON THE EDGE OF THE BUILDING.

THE TSI OBSERVED IN THE MECHANICAL ROOM CONSISTED OF FIBERGLASS. IF DURING RENOVATION HARD PACKED TSI IS OBERVED THIS MATERIAL CONTAINS ASBESTOS AND MUST BE REMOVED AS SUCH.

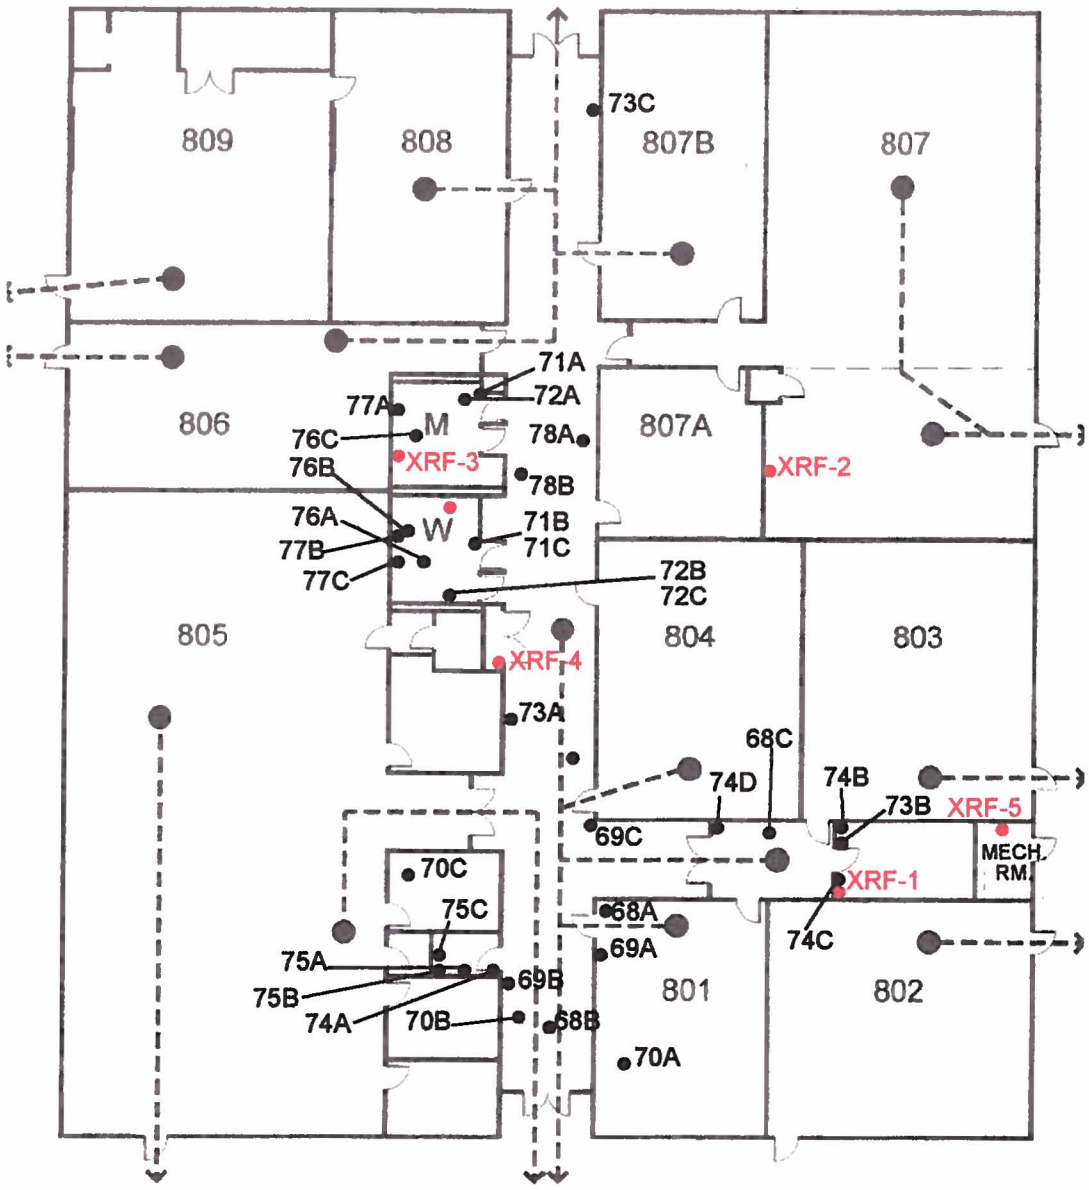
NOTES: BUILDING MATERIALS WHICH CONTAIN ASBESTOS INCLUDE THE FOLLOWING: ALL 9"x9"/ 12"x12" VFT/MASTIC, BROWN MASTIC ASSOCIATED WITH THE WHITE 12"x12" CEILING AND WALL TILES, AND BROWN MASTIC ASSOCIATED WITH THE 4" BASEBOARD IN BUILDING.

DUE TO FIELD CONDITIONS THE FOLLOWING MATERIALS WERE NOT SAMPLED AND ARE ASSUMED TO CONTAIN ASBESTOS: POSSIBLE MASTIC BEHIND WALL BOARD LOCATED IN ROOM 805.

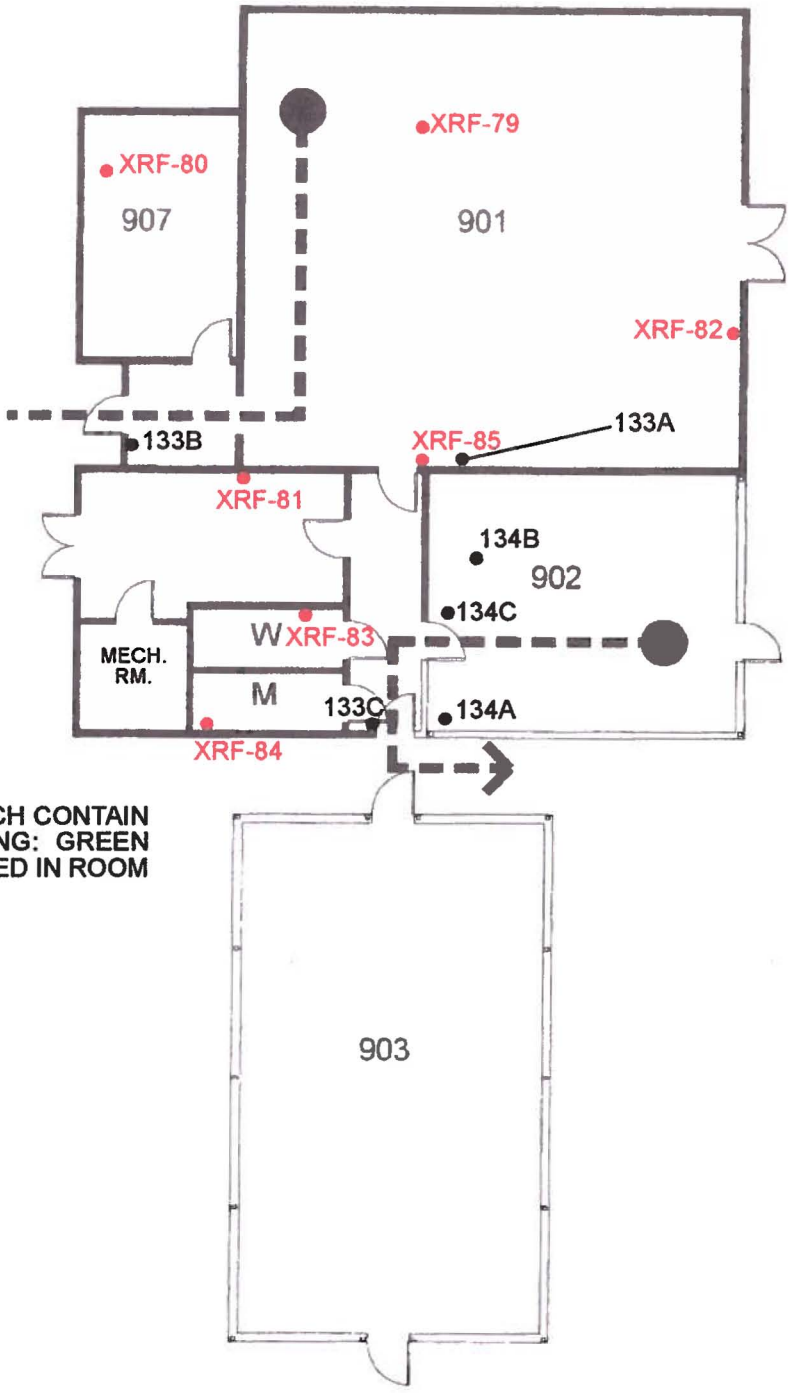
NOTES: BUILDING MATERIALS WHICH CONTAIN ASBESTOS INCLUDE THE FOLLOWING: GREEN SHEET FLOORING MATERIAL LOCATED IN ROOM 902.

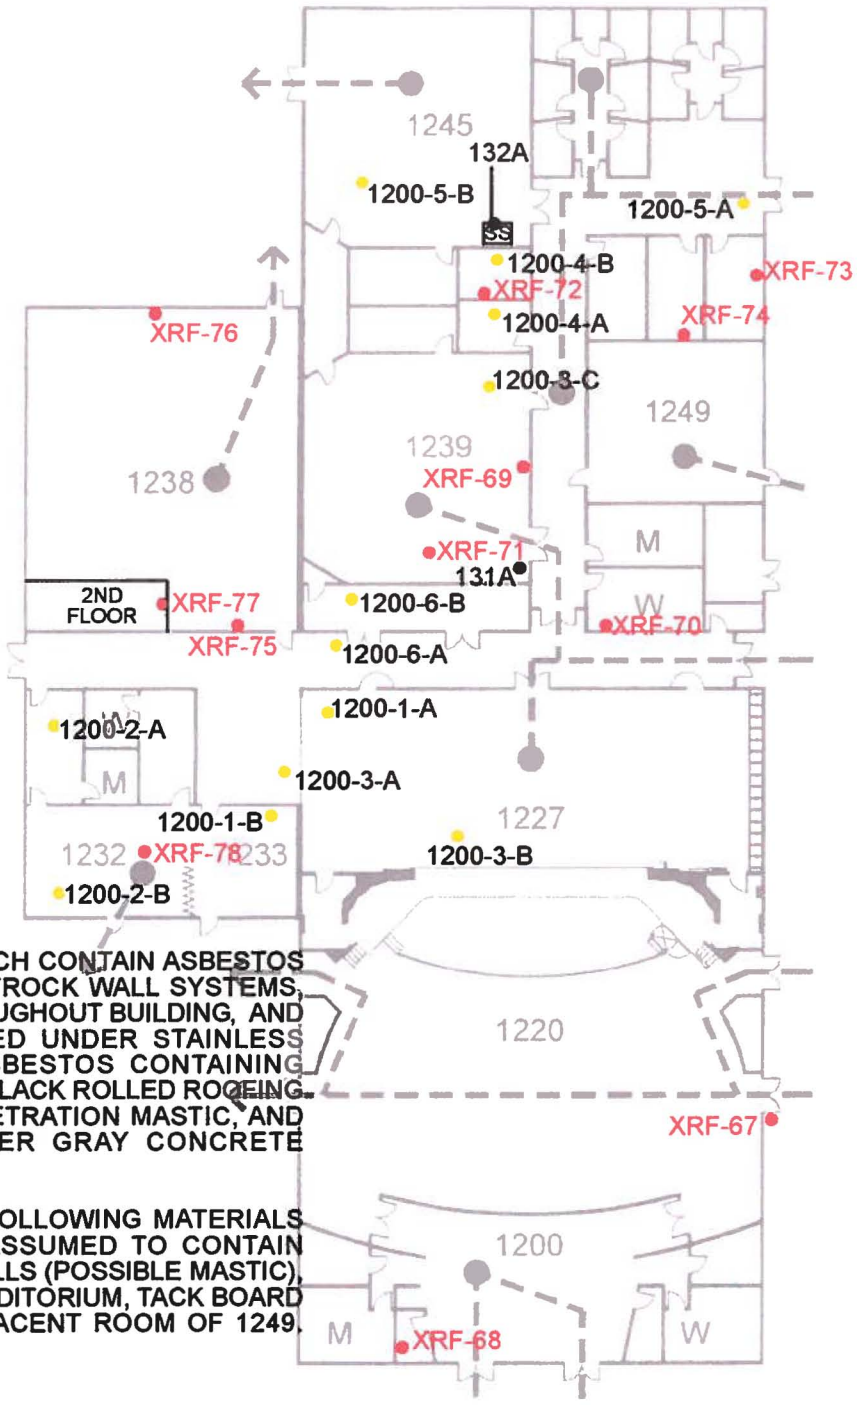
NOTES: BUILDING MATERIALS WHICH CONTAIN ASBESTOS INCLUDE THE FOLLOWING: SHEETROCK WALL SYSTEMS, 9"x9"/12"x12" VFT AND MASTIC THROUGHOUT BUILDING, AND BLACK SPRAY MATERIAL LOCATED UNDER STAINLESS STEEL SINK IN ROOM 1245. ASBESTOS CONTAINING MATERIALS ON ROOF CONSIST OF BLACK ROLLED ROOFING LOCATED IN PARAPIT, BLACK PENETRATION MASTIC, AND BLACK ASPHALT ROOFING UNDER GRAY CONCRETE SHINGLES.

DUE TO FIELD CONDITIONS THE FOLLOWING MATERIALS WERE NOT SAMPLED AND ARE ASSUMED TO CONTAIN ABSBESTOS: WOOD SIDING ON WALLS (POSSIBLE MASTIC), PLASTER CEILING IN FOYER AND AUDITORIUM, TACK BOARD LOCATED IN ROOM 1245 AND ADJACENT ROOM OF 1249.

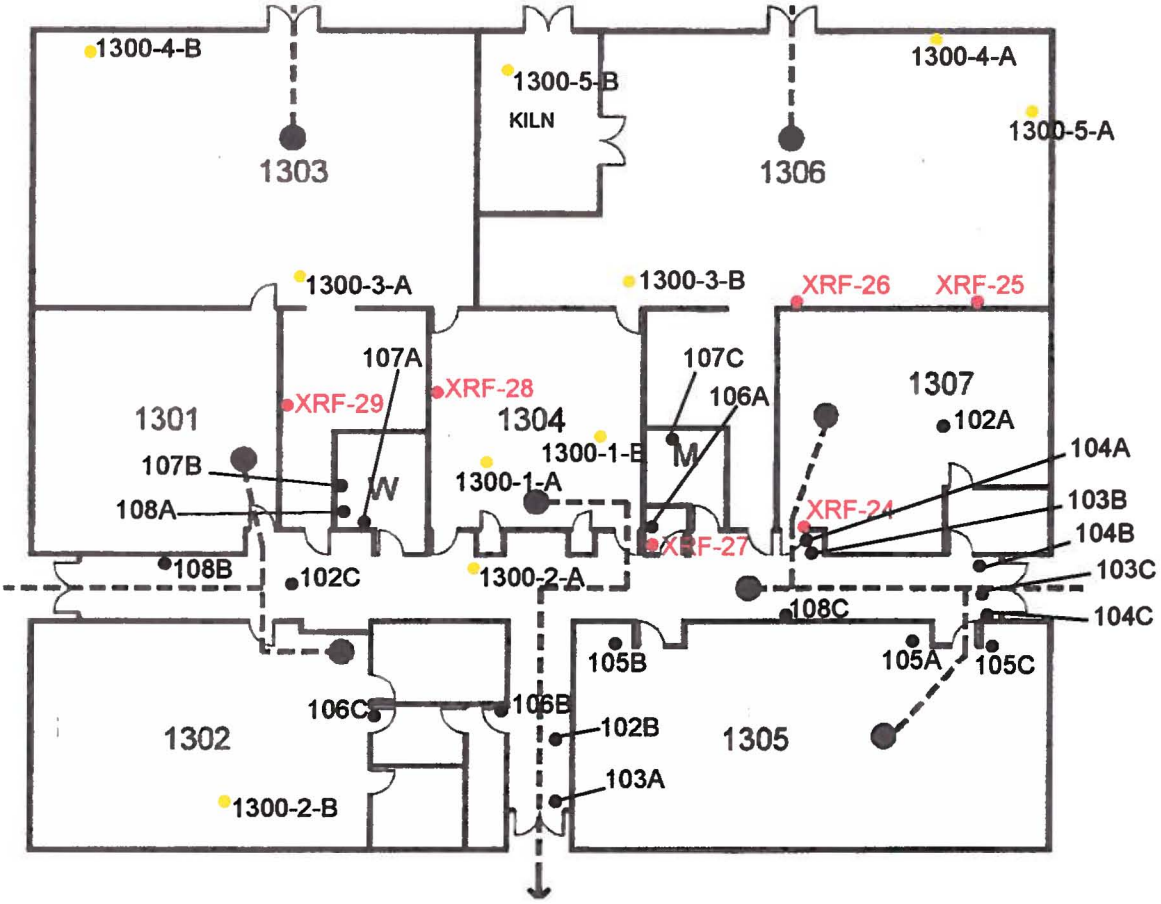
NOTES: BUILDING MATERIALS WHICH CONTAIN ASBESTOS INCLUDE THE FOLLOWING: OFF-WHITE WITH BROWN FLECK 12"x12" VFT/BLACK MASTIC LOCATED IN ROOMS 1301/1303 (ADJ. ROOM)/1306 (ADJ. ROOM)/1302/1304, BROWN MASTIC ASSOCIATED WITH THE 4" BROWN BASEBOARD, SHEETROCK WALL SYSTEMS, BEIGE HVAC TAPING LOCATED IN THE PLENUM, AND BROWN MASTIC ASSOCIATED WITH THE 12"x12" WALL AND CEILING TILES. ASBESTOS CONTAINING MATERIALS ON ROOF CONSIST OF BLACK ROLLED ROOFING LOCATED IN THE PARAPIT AND PENETRATION MASTIC.

DUE TO FIELD CONDITIONS THE FOLLOWING MATERIALS WERE NOT SAMPLED AND ARE ASSUMED TO CONTAIN ABESTOS: WOOD PANELING IN ROOMS 1306 AND 1302 (POSSIBLE MASTIC), 4'x4' CEILING PANELS IN ROOM 1306, AND BRICKS IN KILN.

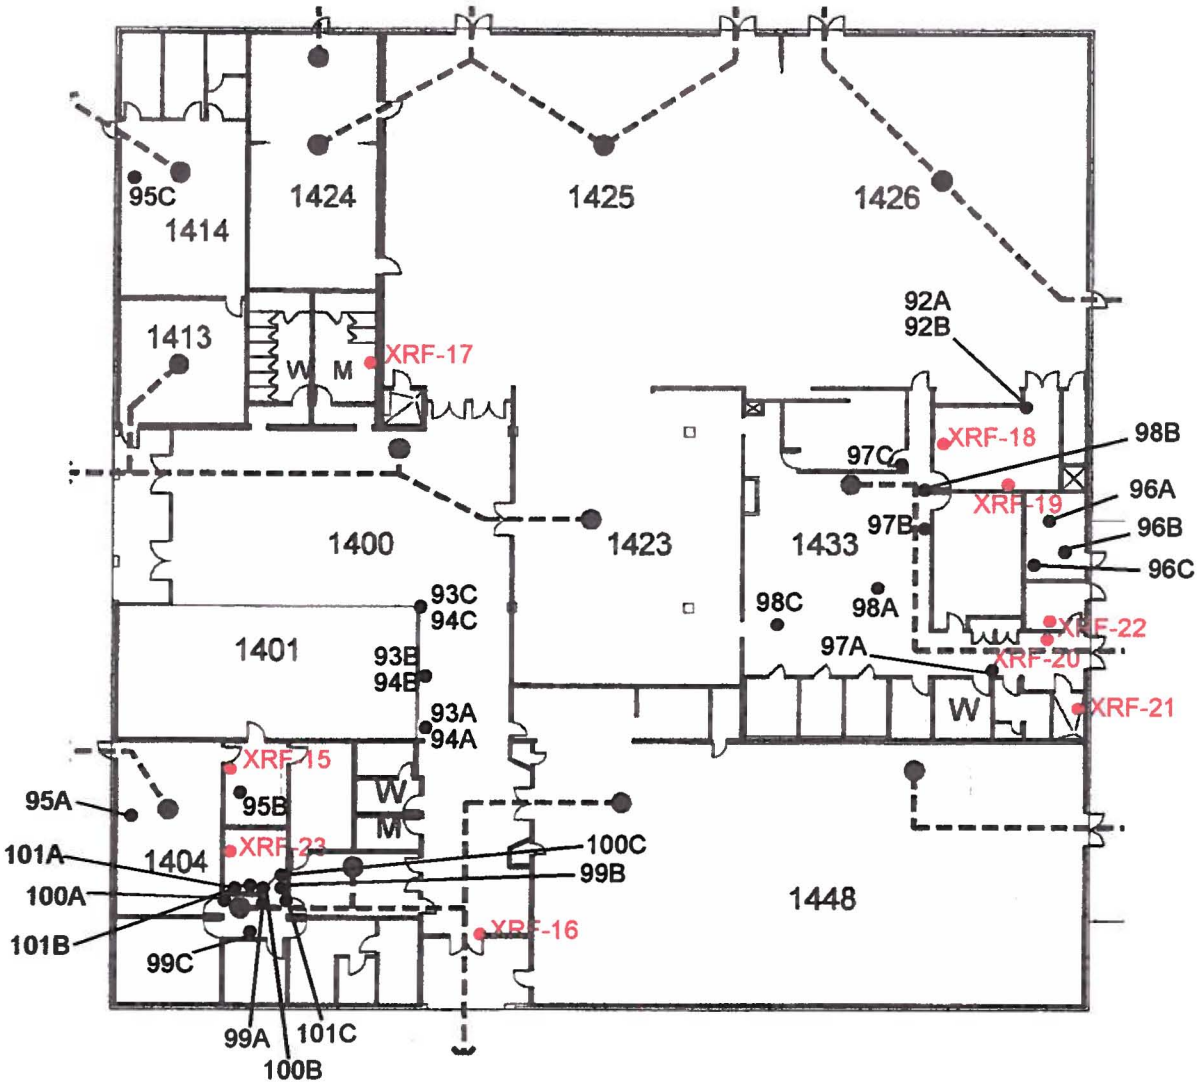
NOTES: BUILDING MATERIALS WHICH CONTAIN ASBESTOS INCLUDE THE FOLLOWING: WHITE TSI (HARD PACK) LOCATED IN IN MECHANICAL ROOM AND 9"x9"/12"x12" VFT/MASTIC.

DUE TO FIELD CONDITIONS THE FOLLOWING MATERIALS WERE NOT SAMPLED AND ARE ASSUMED TO CONTAIN ASBESTOS: WALL BOARD (POSSIBLE MASTIC) LOCATED IN ROOM 1404/1424, AND BROWN MASTIC ASSOCIATED WITH THE 12"x12" WHITE CEILING AND WALL TILES.

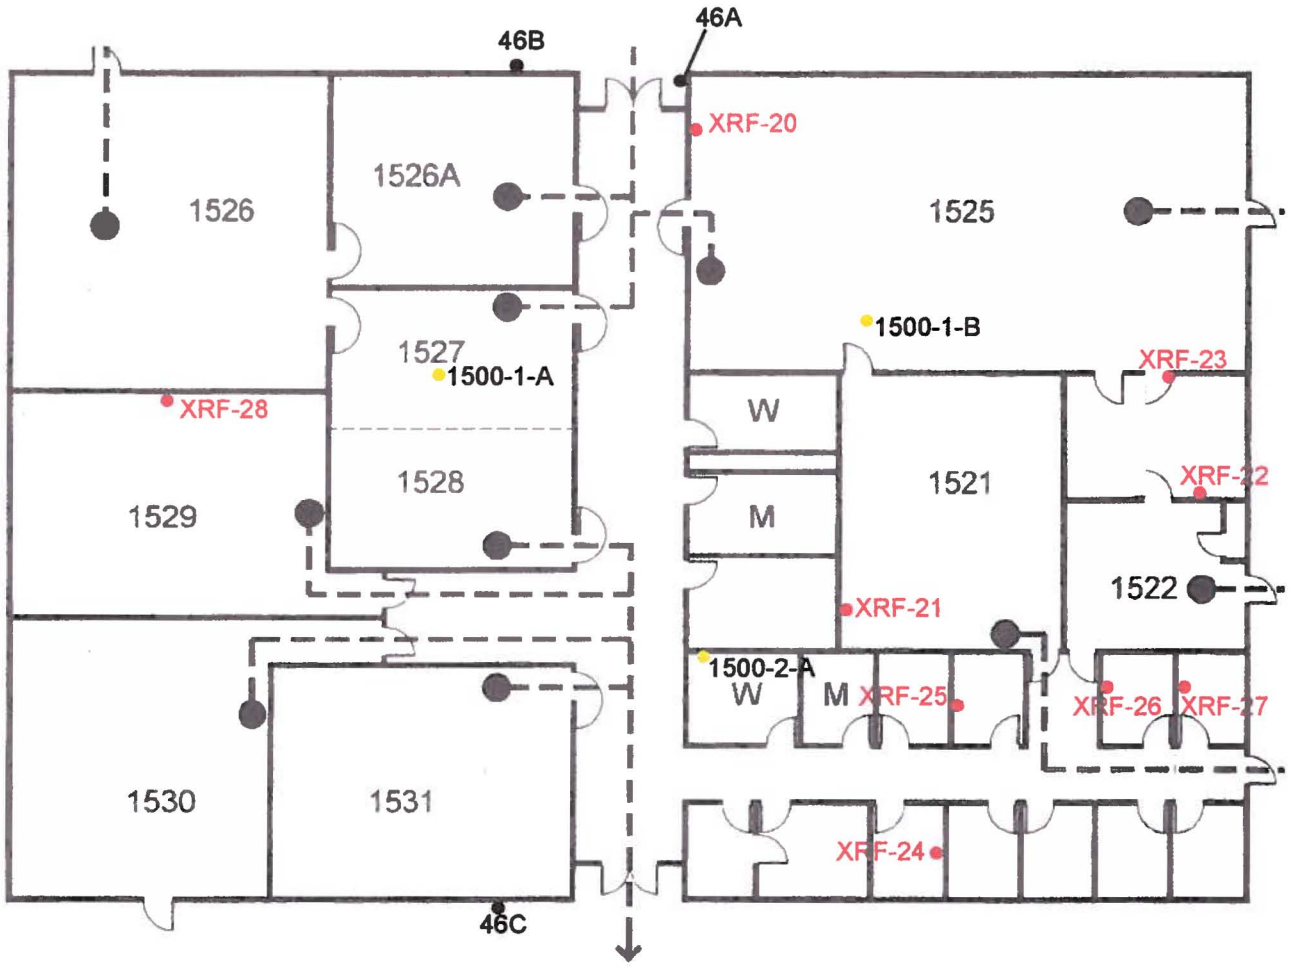
NOTES: BUILDING MATERIALS WHICH CONTAIN ASBESTOS INCLUDE THE FOLLOWING: ALL 9"x9"/12"x12" VFT/MASTIC AND SHEETROCK WALL SYSTEMS. ASBESTOS CONTAINING MATERIALS ON TH ROOF CONSIST OF THE BLACK ROLLED ROOFING MATERIAL LOCATED IN THE PARAPIT, GRAY PVC PUTTY LOCATED IN THE PARAPIT, BLACK ASPHALT ROLLED ROOFING MATERIAL AND BLACK PUTTY LOCATED ON THE EDGE OF THE BUILDING.

DUE TO FIELD CONDITIONS THE FOLLOWING MATERIALS WERE NOT SAMPLED AND ARE ASSUMED TO CONTAIN ASBESTOS: WALL BOARD (POSSIBLE MASTIC) LOCATED IN ROOMS 1511/1526 (WEST WALL).

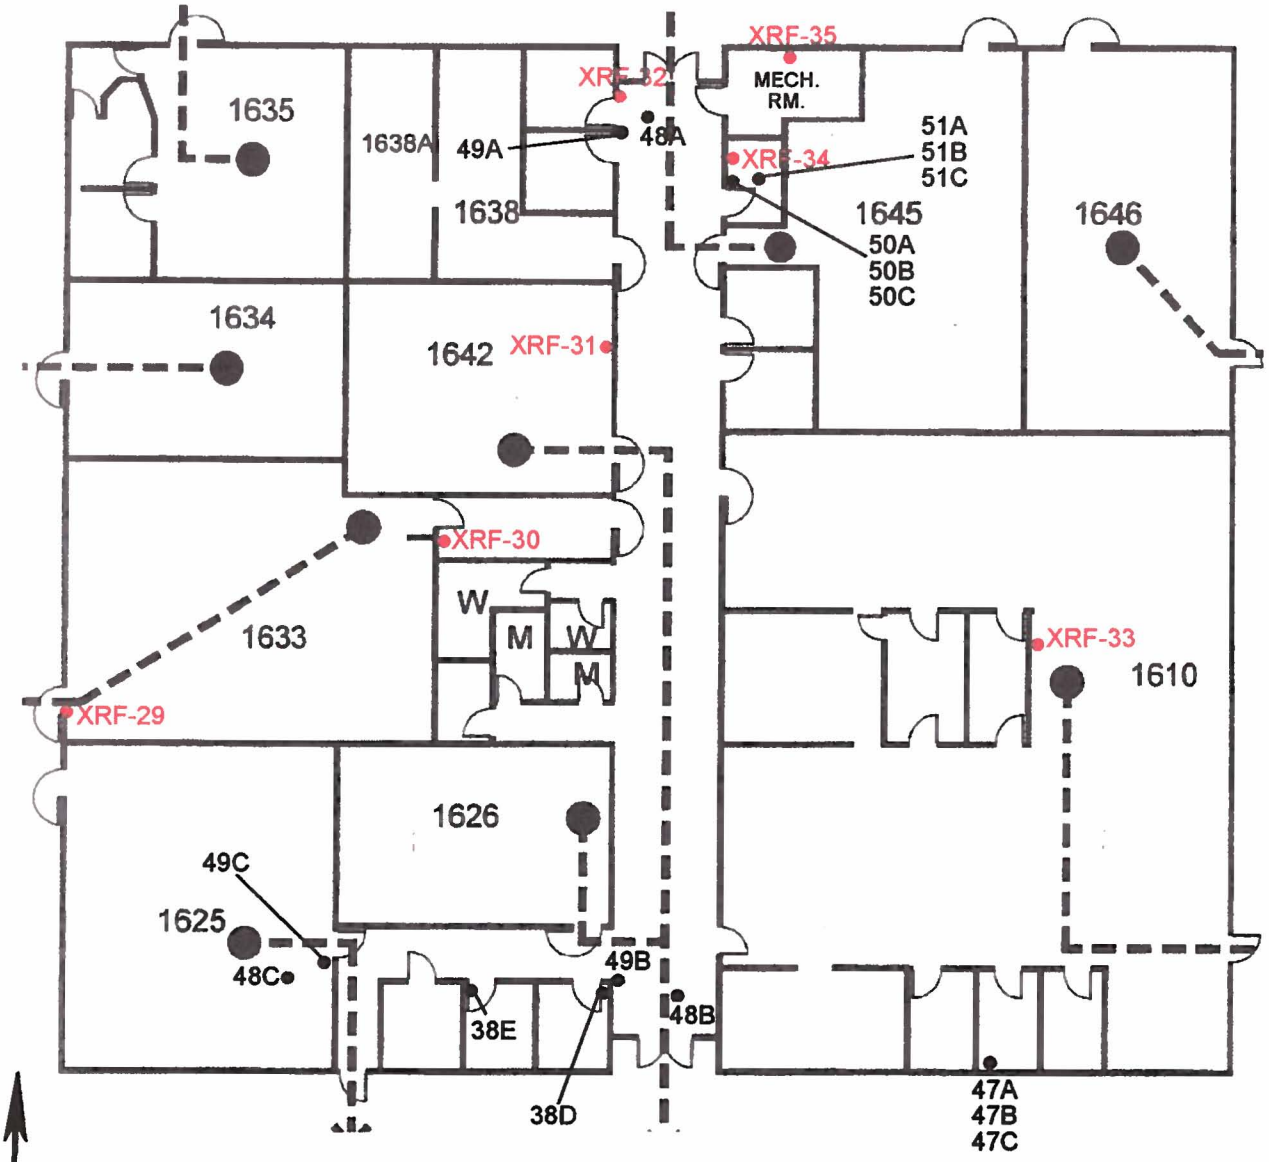
NOTES: BUILDING MATERIALS WHICH CONTAIN ASBESTOS INCLUDE THE FOLLOWING: ALL 9"x9"/12"x12" VFT/MASTIC AND SHEETROCK WALL SYSTEMS.

THE TSI OBSERVED IN THE MECHANICAL ROOM CONSISTED OF FIBERGLASS. IF DURING RENOVATION HARD PACKED TSI IS OBSERVED, THIS MATERIAL CONTAINS ASBESTOS AND MUST BE REMOVED AS SUCH.

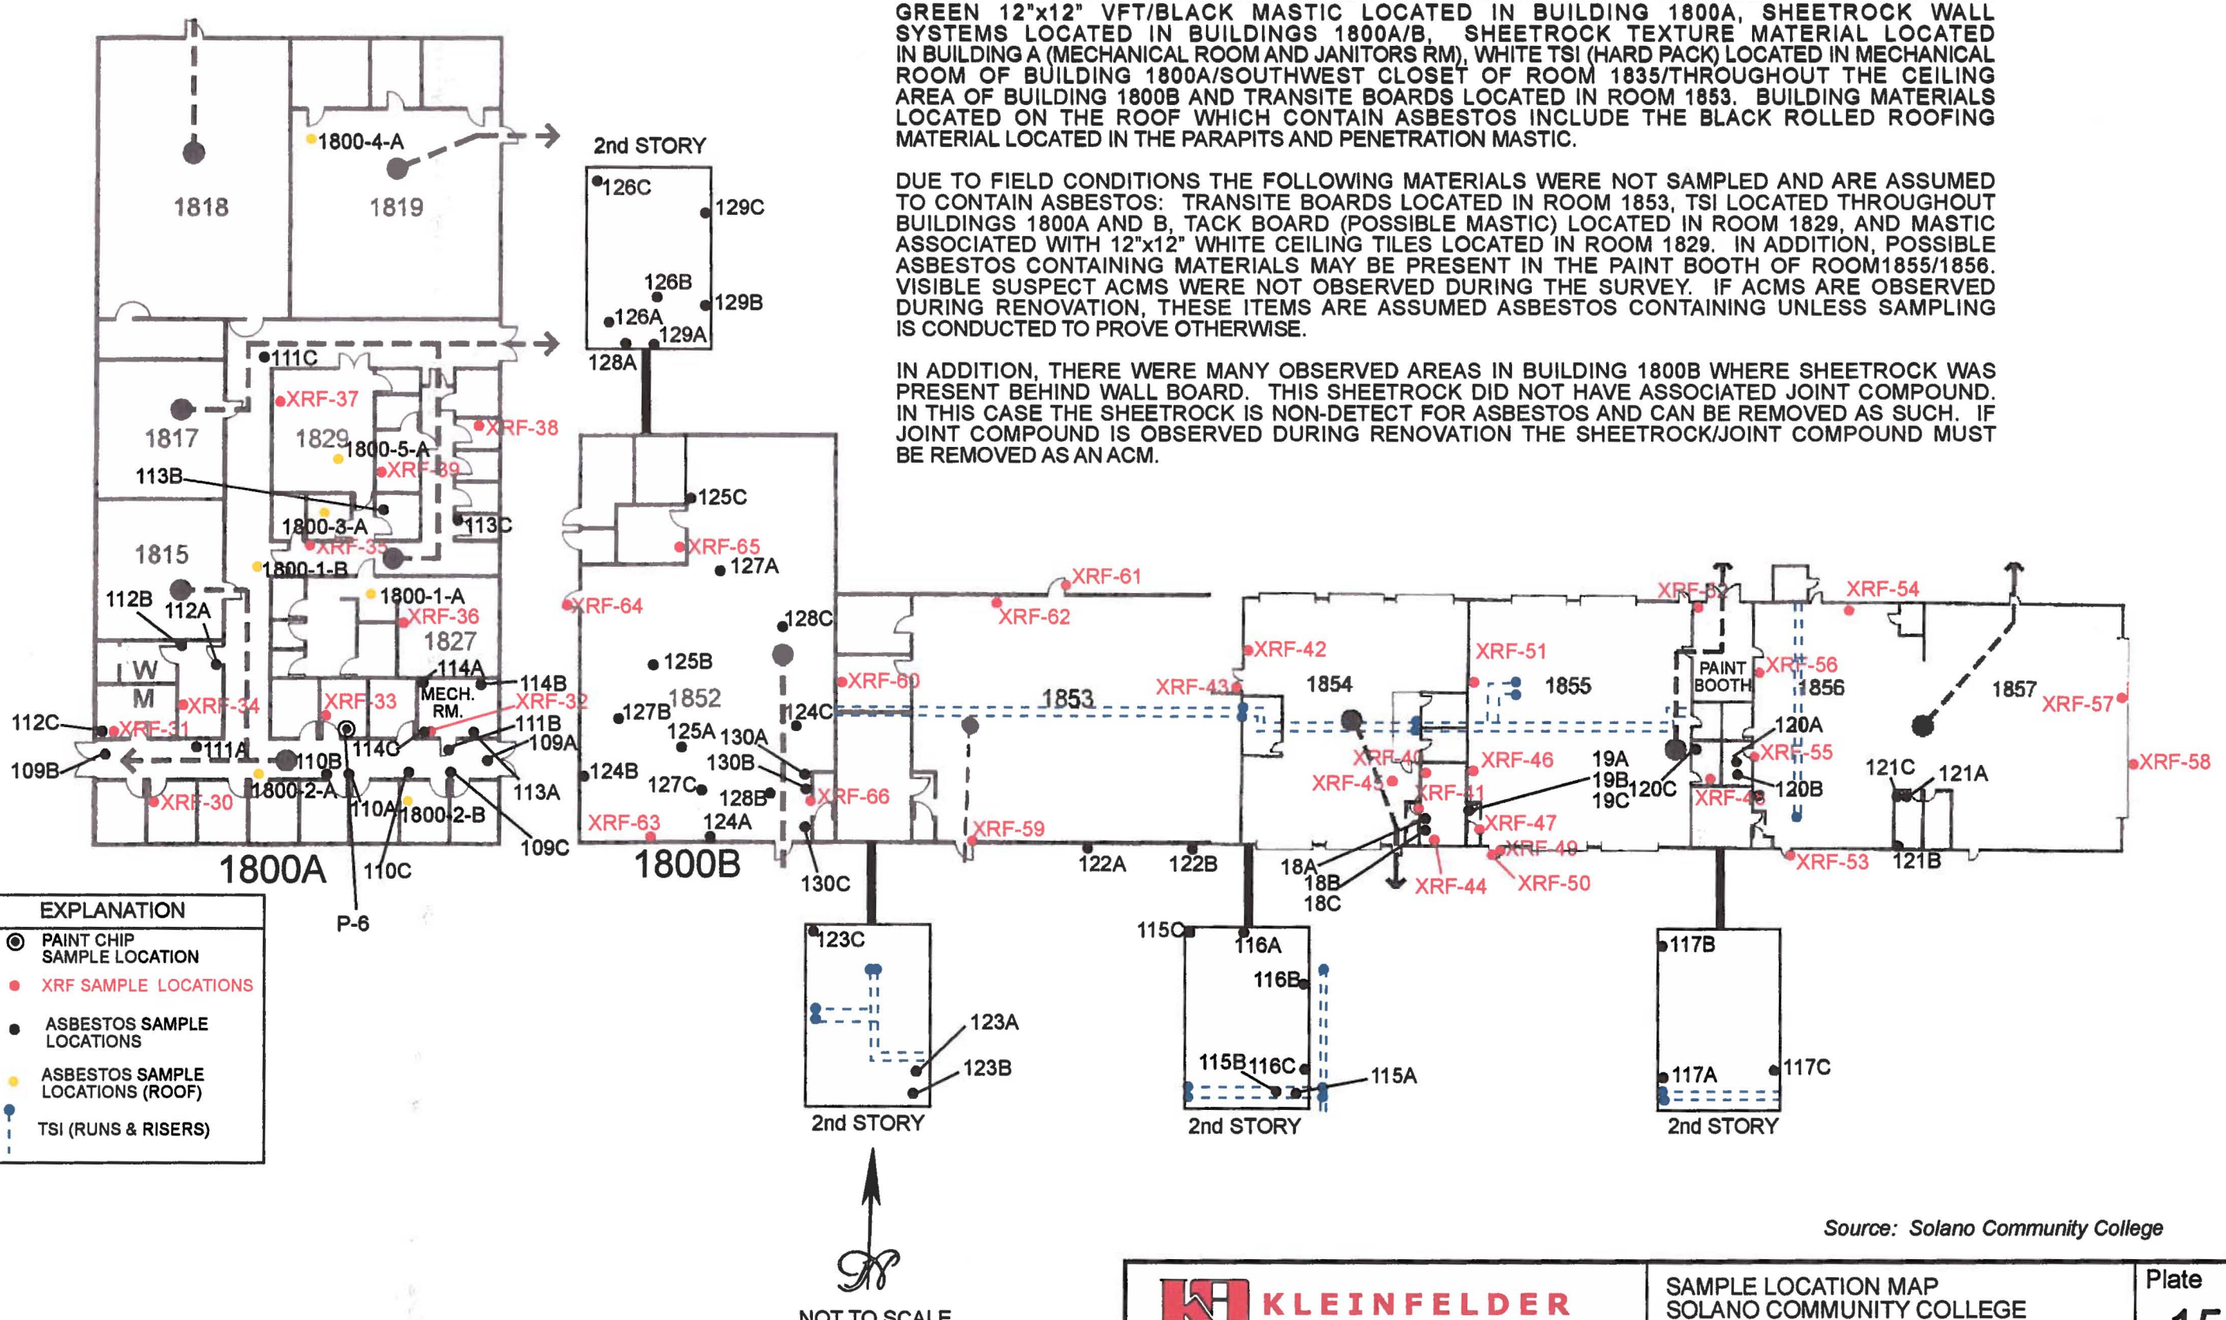
KLEINFELDER		SAMPLE LOCATION MAP SOLANO COMMUNITY COLLEGE VOCATIONAL COMPLEX - 1800 FAIRFIELD, CALIFORNIA
Project No. 44156	Date: 04/29/2004 Filename: Plate 15-Bldg. 1800	Plate 15

DUE TO FIELD CONDITIONS THE FOLLOWING MATERIALS WERE NOT SAMPLED AND ARE ASSUMED TO CONTAIN ASBESTOS: TRANSITE BOARDS LOCATED IN ROOM 1853, TSI LOCATED THROUGHOUT BUILDINGS 1800A AND B, TACK BOARD (POSSIBLE MASTIC) LOCATED IN ROOM 1829, AND MASTIC ASSOCIATED WITH 12"x12" WHITE CEILING TILES LOCATED IN ROOM 1829. IN ADDITION, POSSIBLE ASBESTOS CONTAINING MATERIALS MAY BE PRESENT IN THE PAINT BOOTH OF ROOM1855/1856. VISIBLE SUSPECT ACMS WERE NOT OBSERVED DURING THE SURVEY. IF ACMS ARE OBSERVED DURING RENOVATION, THESE ITEMS ARE ASSUMED ASBESTOS CONTAINING UNLESS SAMPLING IS CONDUCTED TO PROVE OTHERWISE.

IN ADDITION, THERE WERE MANY OBSERVED AREAS IN BUILDING 1800B WHERE SHEETROCK WAS PRESENT BEHIND WALL BOARD. THIS SHEETROCK DID NOT HAVE ASSOCIATED JOINT COMPOUND. IN THIS CASE THE SHEETROCK IS NON-DETECT FOR ASBESTOS AND CAN BE REMOVED AS SUCH. IF JOINT COMPOUND IS OBSERVED DURING RENOVATION THE SHEETROCK/JOINT COMPOUND MUST BE REMOVED AS AN ACM.

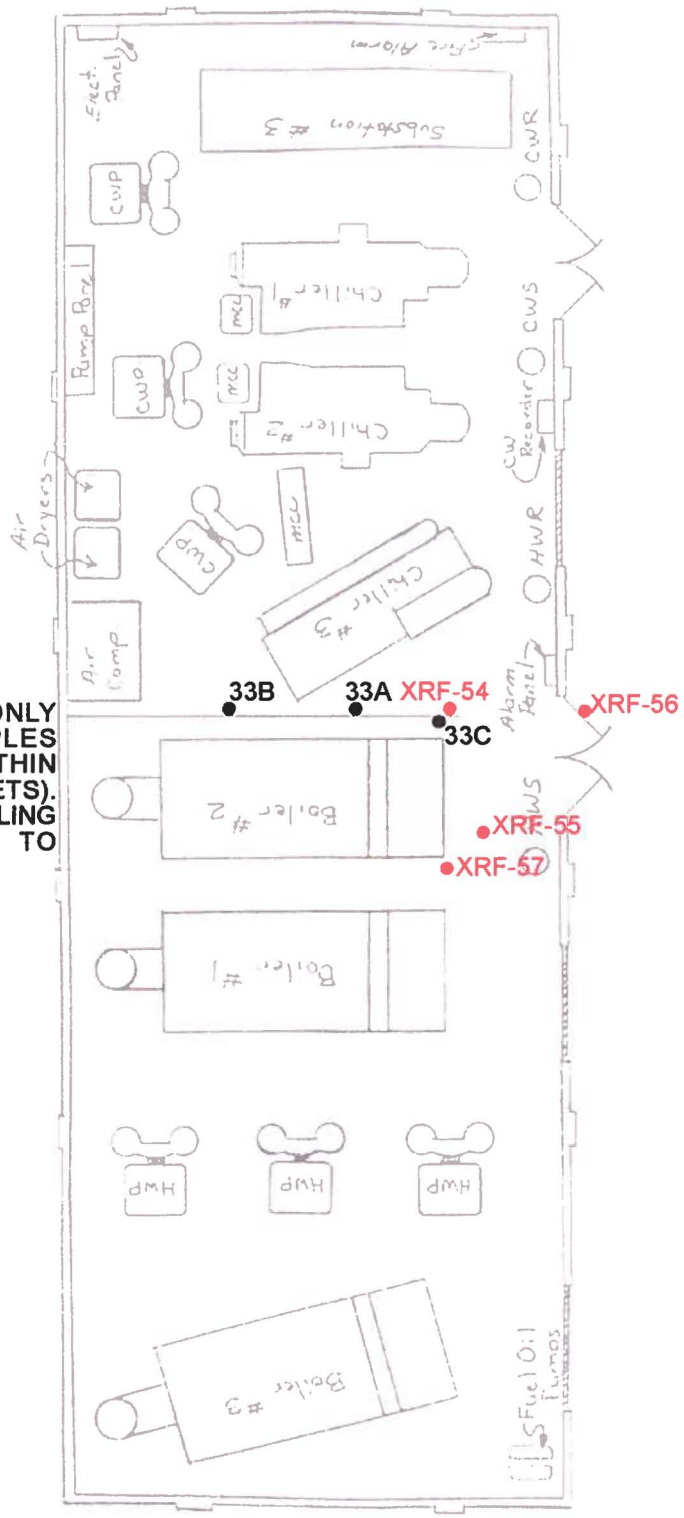
NOTES: NO VISIBLE TSI (HARD PACK) ONLY TSI MADE OF FIBERGLASS. NO SAMPLES COLLECTED OF WORKING PARTS (I.E. WITHIN BOILER, WITHIN CHILLER, VIBRATION GASKETS). IF THESE ITEMS ARE TO BE RENOVATED SAMPLING WILL NEED TO BE CONDUCTED PRIOR TO CONTRACTOR DISTURBANCE.

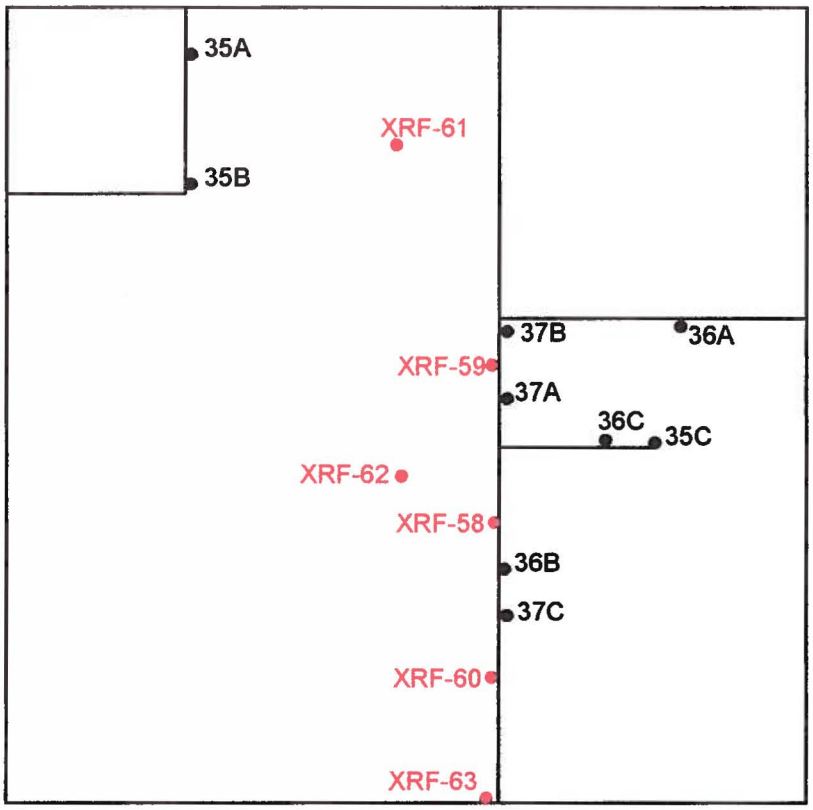
NOTES: BUILDING MATERIALS WHICH CONTAIN ASBESTOS INCLUDE THE FOLLOWING: SHEETROCK WALL SYSTEMS AND ASSOCIATED DRYWALL TEXTURE MATERIAL.

TSI OBSERVED CONSISTED OF FIBERGLASS. IF DURING RENOVATION HARD PACK TSI IS OBSERVED THIS MATERIAL IS ASSUMED TO CONTAIN ASBESTOS AND MUST BE REMOVED AS SUCH.

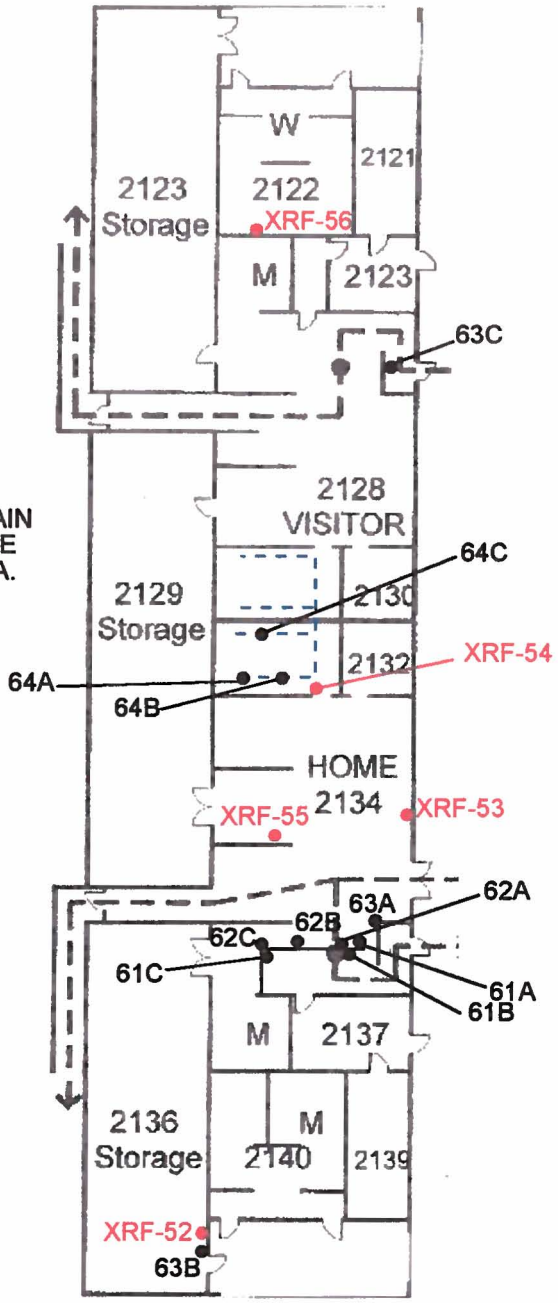
NOTES: BUILDING MATERIALS WHICH CONTAIN ASBESTOS INCLUDE THE FOLLOWING: WHITE TSI MATERIAL LOCTED IN THE SHOWER AREA.
